**APPENDIX I-5**  
*Final Backfill Report*

August 6, 2007

Final  
Backfill Report  
Large Excavation Site- Leasehold Property  
Former General Mills Facility  
Vallejo, California

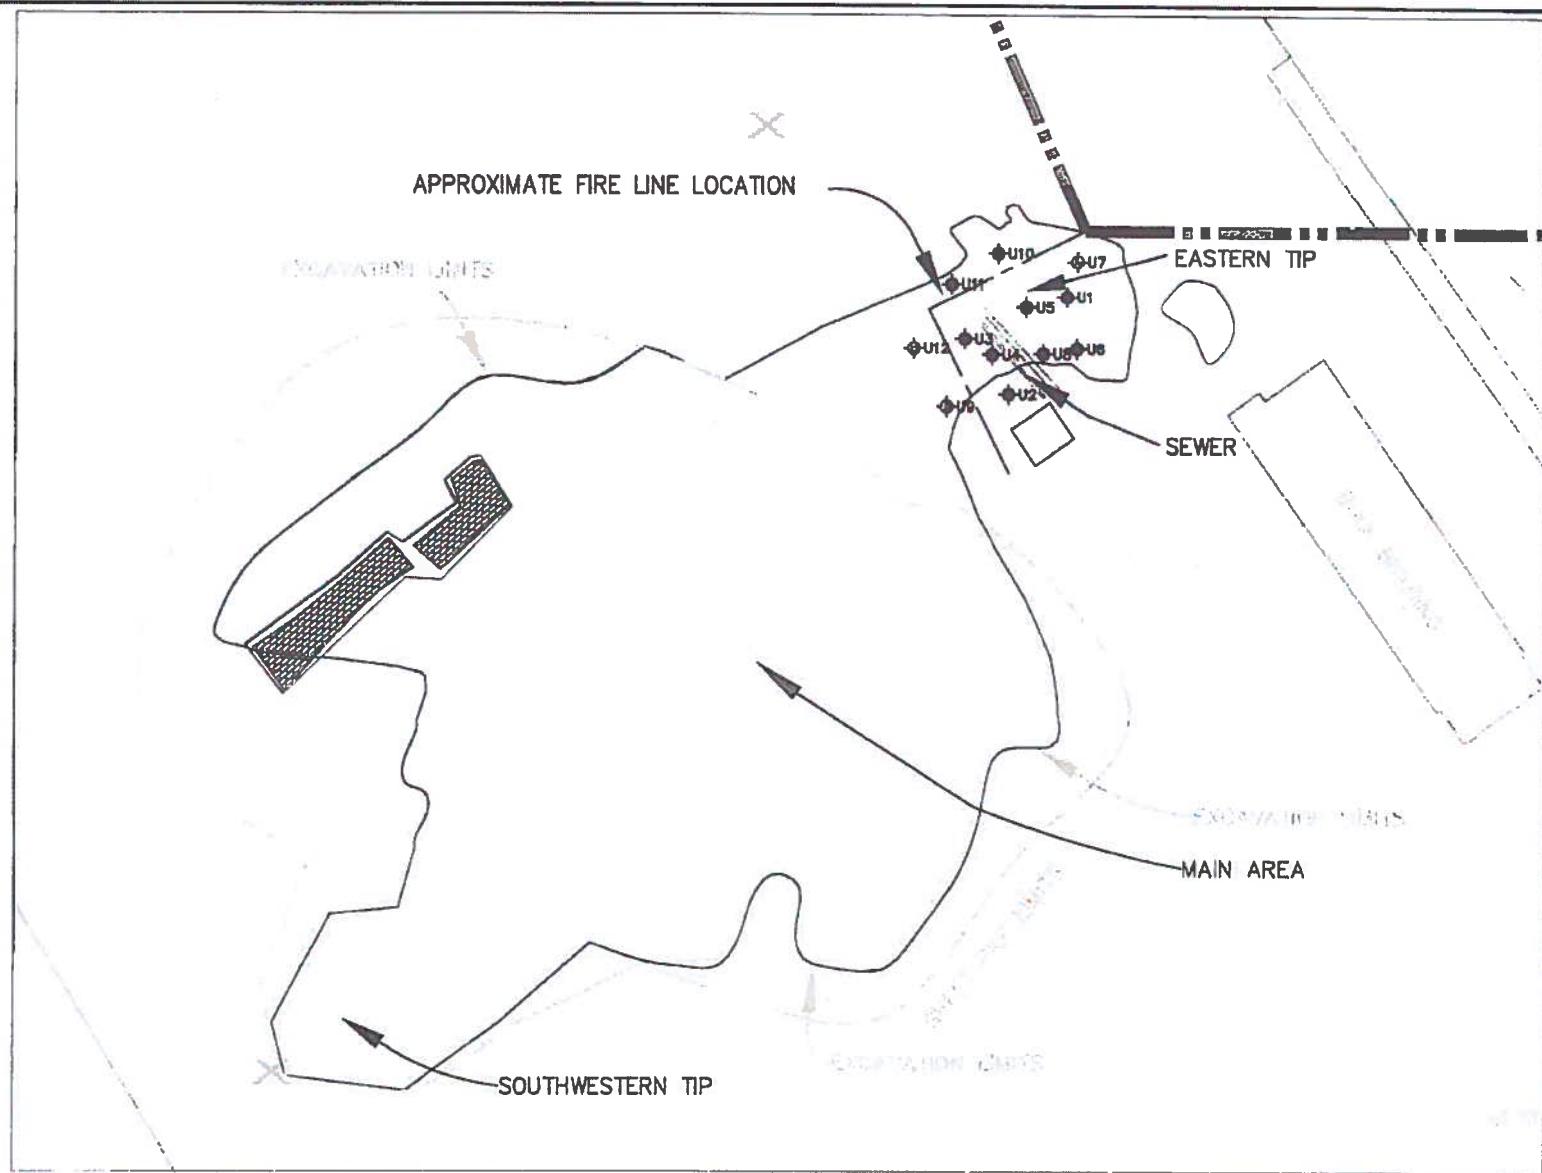
FIG NO.  
2

The backfilling operation for the eastern tip was conducted and completed in January 2007. A portable compactor was used to compact the soil due to limited access in the vicinity of buried utilities in the area. The excavation was backfilled with the stockpiled overburden soil. Twelve compaction tests (test numbers U1 through U12) were conducted on the compacted overburden soil. The field compaction test results are summarized in Table 2 and the test locations are shown in Figure 2. Due to random nature of

the backfill materials, ERRG's field engineer selected a compaction curve of similar soil type to evaluate the relative compaction (percentage of in-place dry density divided by maximum dry density as determined by ASTM D1557). The relative compaction was equal to or above the required 90 percent relative compaction.

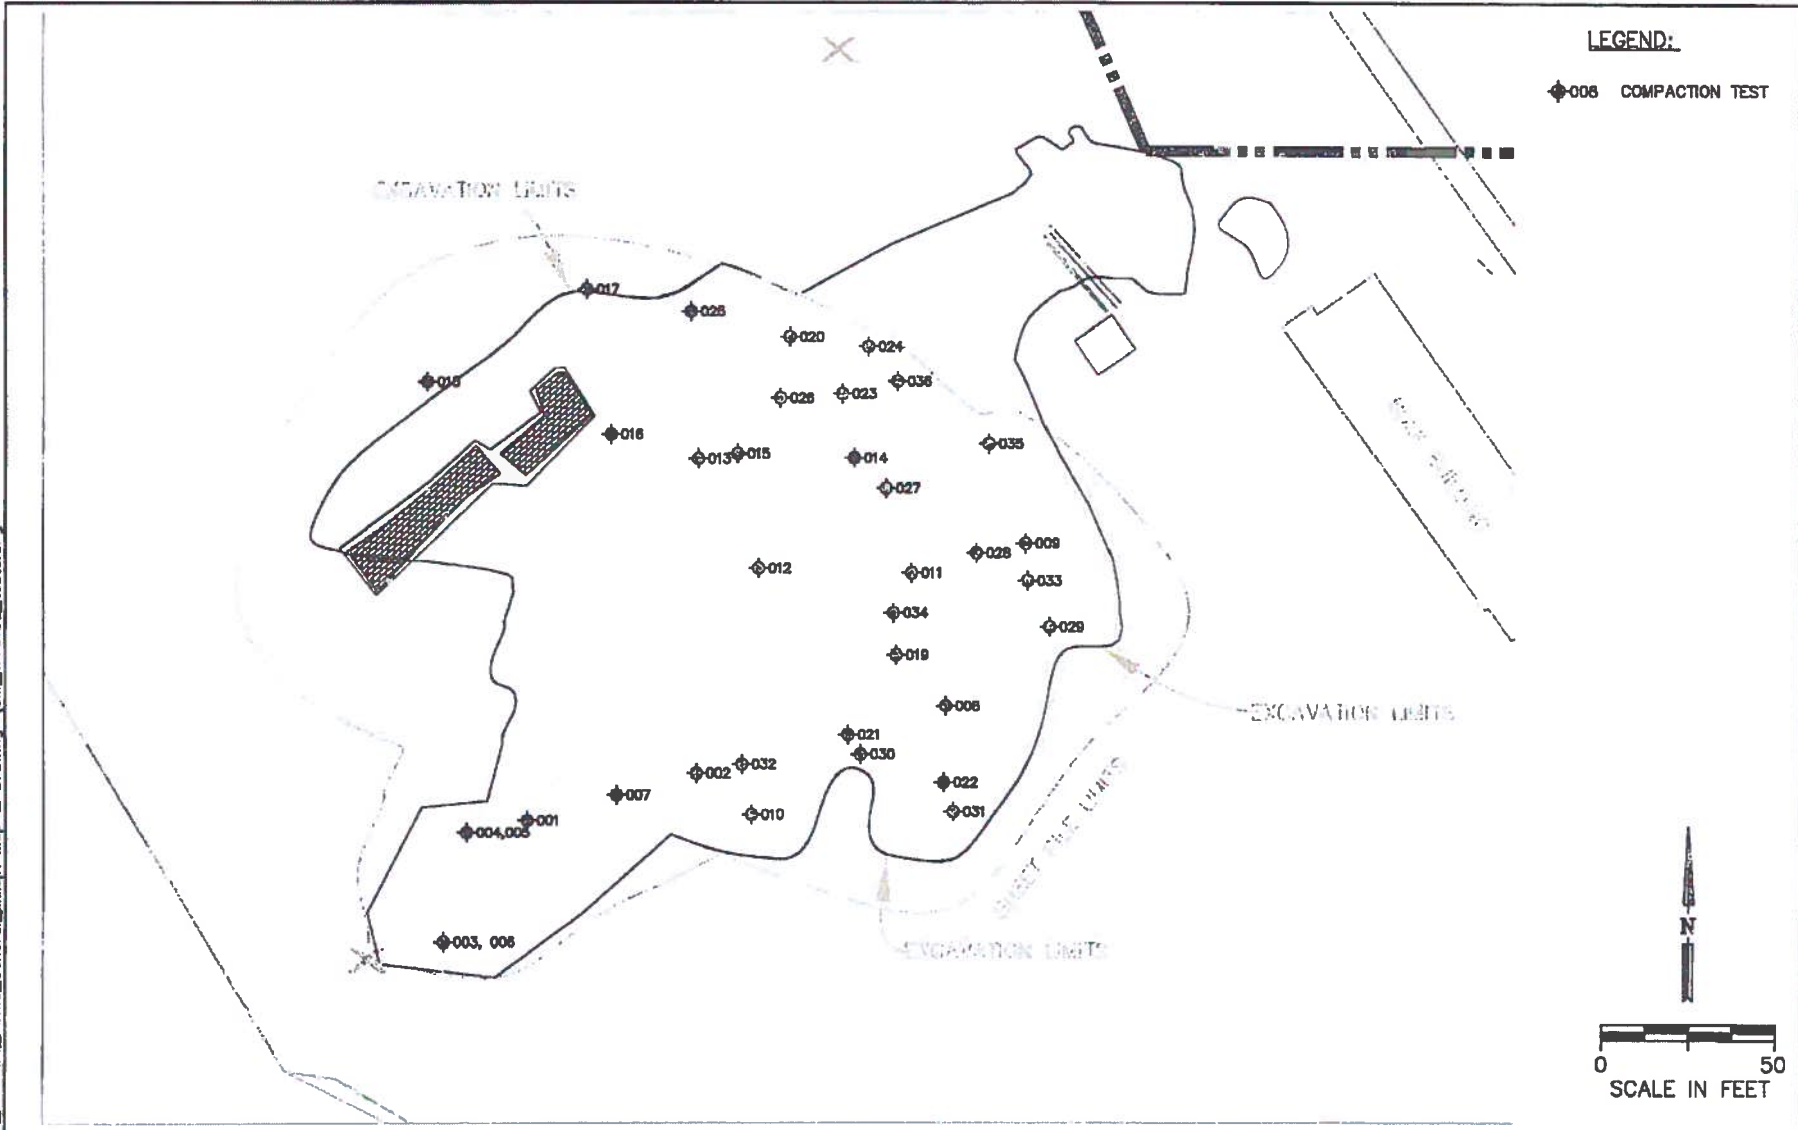
ERRG PROJECT NO.  
26-150  
FIG. NO.  
3

Ninety five compaction tests (test numbers 001 through 095) were conducted on the quick lime mixed chemically-treated soil. The field compaction test results are summarized in Table 3 and the test locations are shown in Figures 3 to 5. In general the relative compaction was equal to or above the required 90 percent relative compaction except for the tests (test numbers 001 and 002) conducted in the first lift of compacted soil around the south-western tip. Due to the softness and wetness of the excavated subgrade, the compaction energy became less effective in that area. The relative compaction for those tests ranged from 84 to 89 percent. The subsequent lifts of soil, however, were placed and compacted on a more stable subgrade. Consequently, the relative compaction for the subsequent lifts was equal to or above 90%.

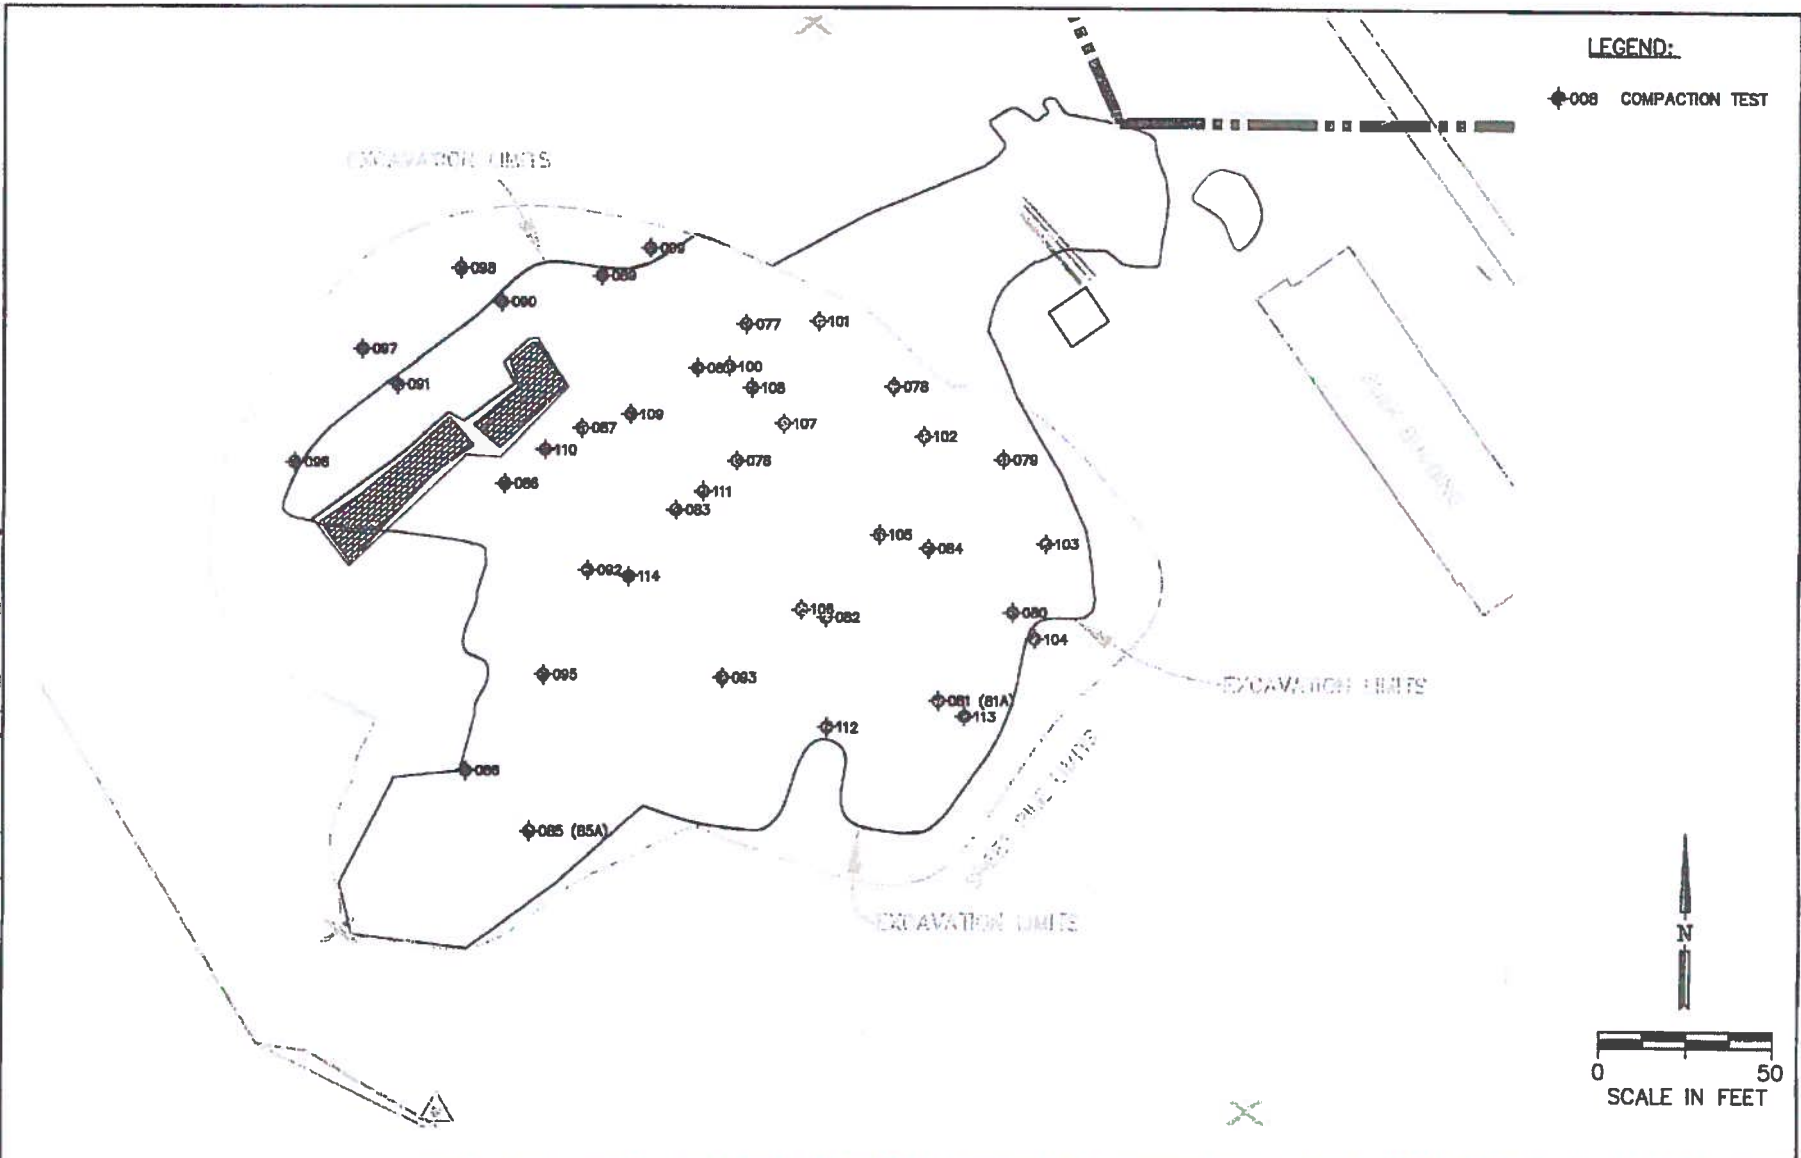
ERRG PROJECT NO.  
26-150  
FIG. NO.  
5

085	5/11/2007	See Fig. 5	Fill/Treated	4.5	101.1	13.6	C302C0	88	Fail, See Retest 85A
086	5/11/2007	See Fig. 5	Fill/Treated	4	109.1	15.6	C302C0	95	Pass
087	5/11/2007	See Fig. 5	Fill/Treated	4	104.1	15.0	C302C0	91	Pass
088	5/11/2007	See Fig. 5	Fill/Treated	4	106.1	15.9	C302C0	92	Pass
089	5/11/2007	See Fig. 5	Fill/Treated	3.5	105.5	16.1	C302C0	92	Pass
090	5/11/2007	See Fig. 5	Fill/Treated	3.5	106.3	17.5	C302C0	93	Pass
091	5/11/2007	See Fig. 5	Fill/Treated	3.5	104.4	15.1	C302C0	91	Pass
092	5/11/2007	See Fig. 5	Fill/Treated	4	111.9	16.3	C1/4C0	93	Pass
093	5/11/2007	See Fig. 5	Fill/Treated	4	115.6	16.2	C1/4C0	96	Pass
85A	5/11/2007	See Fig. 5	Fill/Treated	5.5	105.2	16.1	C302C0	92	Pass
094	5/11/2007	See Fig. 5	Fill/Treated	4	117.2	17.8	C1/4C0	97	Pass
095	5/11/2007	See Fig. 5	Fill/Treated	4.5	105.1	16.4	C302C0	91	Pass
