APPENDIX F
Historical Resources Evaluation

**Sperry Flour Company Site
Vallejo, California**

HISTORIC RESOURCES EVALUATION REPORT

November 10, 2014

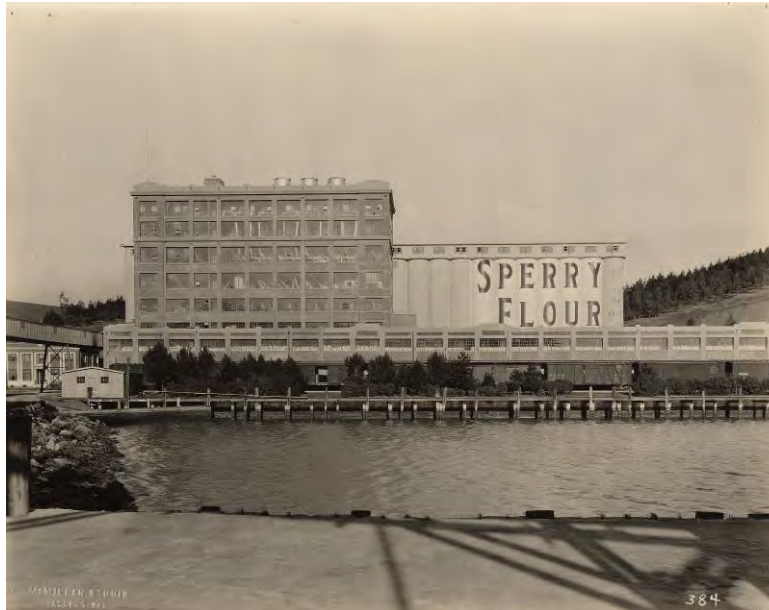
Completed mill, warehouse, and storage bins, ca. 1920. Courtesy Floyd Miller and the Quarter Century Club, General Mills.

Couchot applied to these buildings the most modern design and construction methods available. Ernest Ransome had built the first concrete warehouse in California in the 1880s for borax mining magnate, Francis Marion Smith. It was located in city of Alameda. Only after Ransome patented a new construction method in 1902, however, did reinforced concrete become more widely used. Still, as preeminent industrial architect Albert Kahn noted in 1918, architects and engineers rarely saw beyond the functional possibilities of concrete and rarely saw its aesthetic possibilities. Couchot's design for the mill and associated buildings marked an early effort to fuse the functional and aesthetic potential of the most modern reinforced concrete construction methods available. He created a reinforced concrete skeletal form, which allowed him to maximize the amount of natural light that penetrated the building by installing large, multi-lite windows between the structural columns. The windows also created aesthetic interest, as did the brick veneer applied to the exterior walls, a shaped parapet, and a projecting cornice. Awning windows provided ventilation for the otherwise hot and noisy confines of the mill. A two-story warehouse extended the bottom of the mill by 200 feet to the south and 46 feet to the west. Behind these buildings stood the silo, a reinforced concrete structure that consisted of a head building measuring 48 feet by 51 feet and 124 feet 6 inches high, and a series of storage bins totaling a 1 million bushel capacity. Thirty circular bins measuring 15-feet in diameter and 80 feet high combined with twenty-two intermediate bins to provide storage space for over 11 thousand tons of grain; they were arranged in rows of three. Together, the mill, warehouse, and silo formed a balanced composition as viewed from Mare Island Strait. The silo's wall of windowless, rounded concrete balanced the flat, rectilinear form of the mill and its walls of windows. Similarly, the long horizontal plane of the warehouse provided balance to the vertical plane of the bins and mill, while the three buildings resulted in a pleasantly proportioned stepped massing.²¹

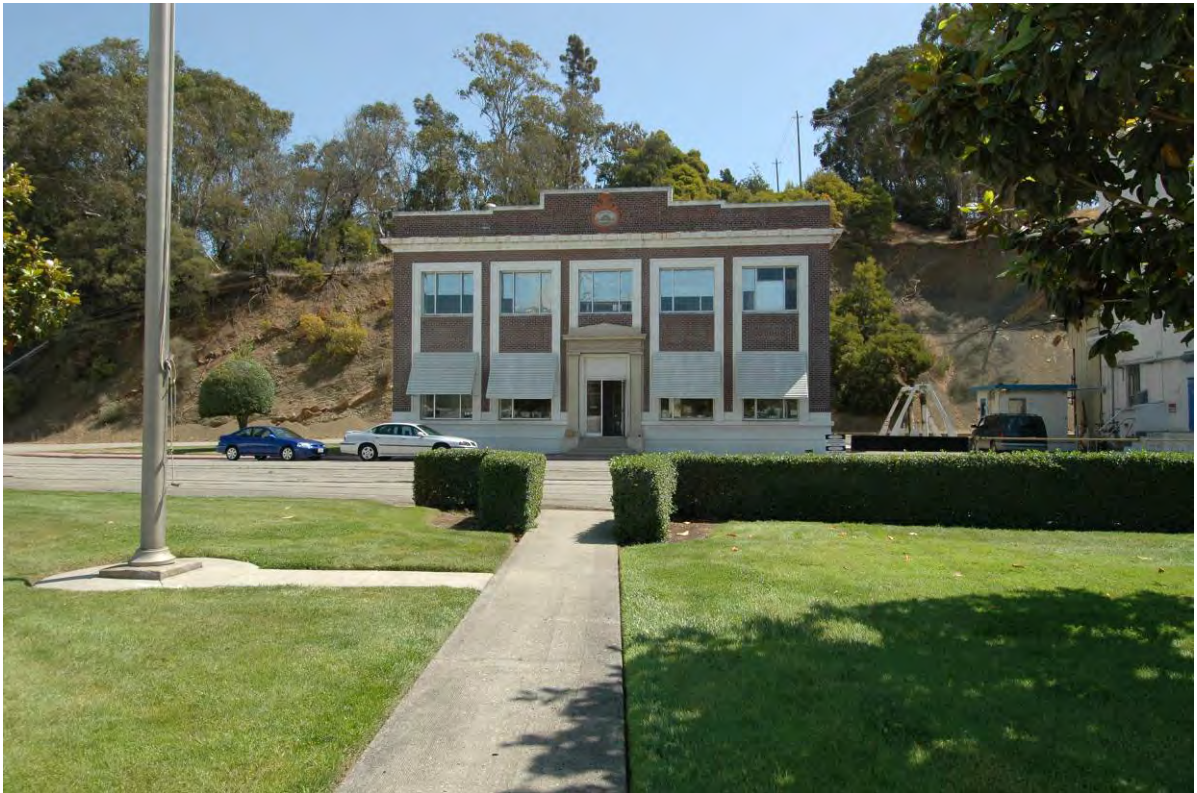
Administration Building, front elevation. Carey & Co., Inc., 2007.

The new plant included several smaller buildings as well. The most prominent of these was, and is, the administration building. This two-story building has a reinforced concrete frame and floor, brick walls, and wooden partitions with metal lath and plaster. A series of ten wood frame casement windows along both the front and rear elevations, as well as a series of six similar windows along the sides of the buildings provided natural light and ventilation. While the administration building complemented the mill and warehouse, it featured several more decorative elements that lend the structure a classical style and signaled its status as the business and science center of the mill, including a stepped parapet, embellished cornice, and Classical entryway. A medallion with the company logo adorns the center of the parapet.

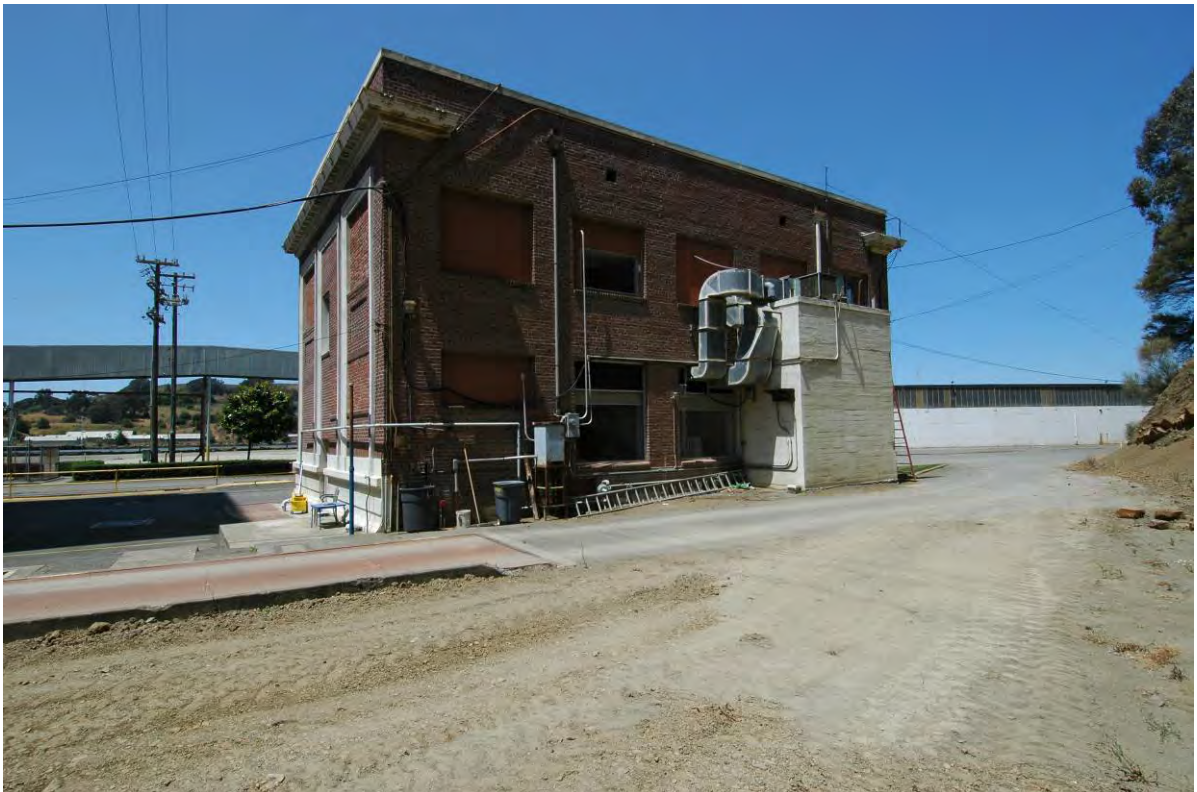
Administration building, rear elevation. Carey & Co., Inc., 2007.

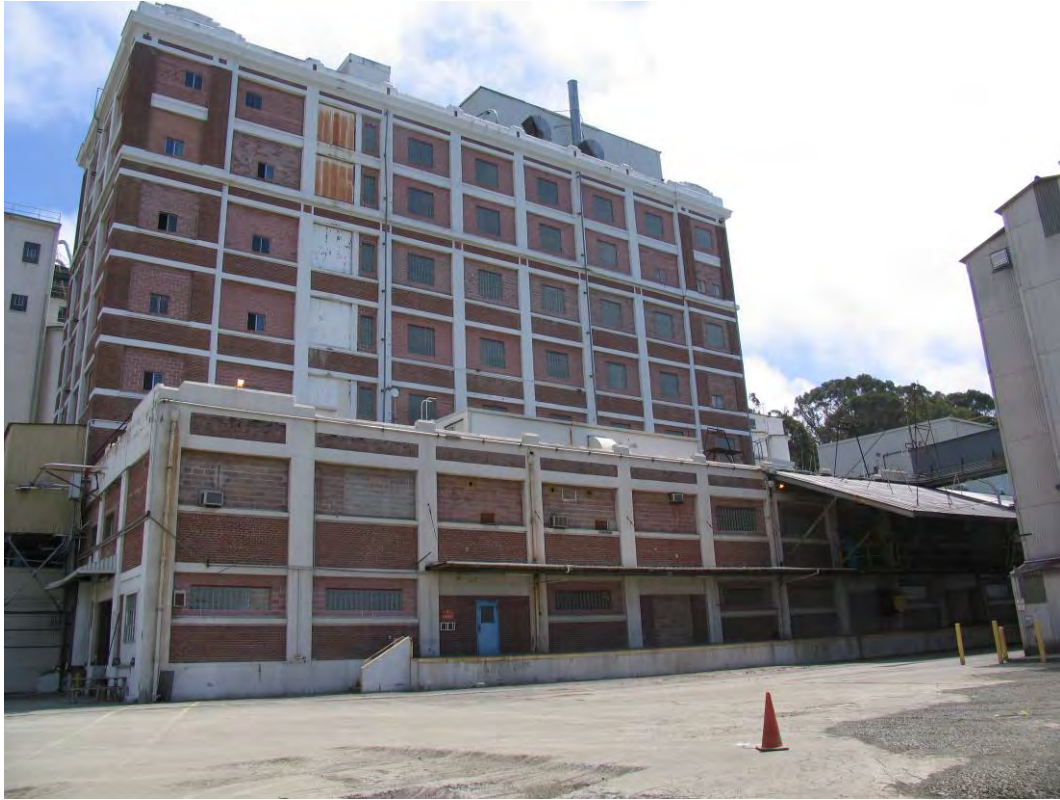
Flour mill and warehouse, west elevation. Carey & Co., Inc., 2007.

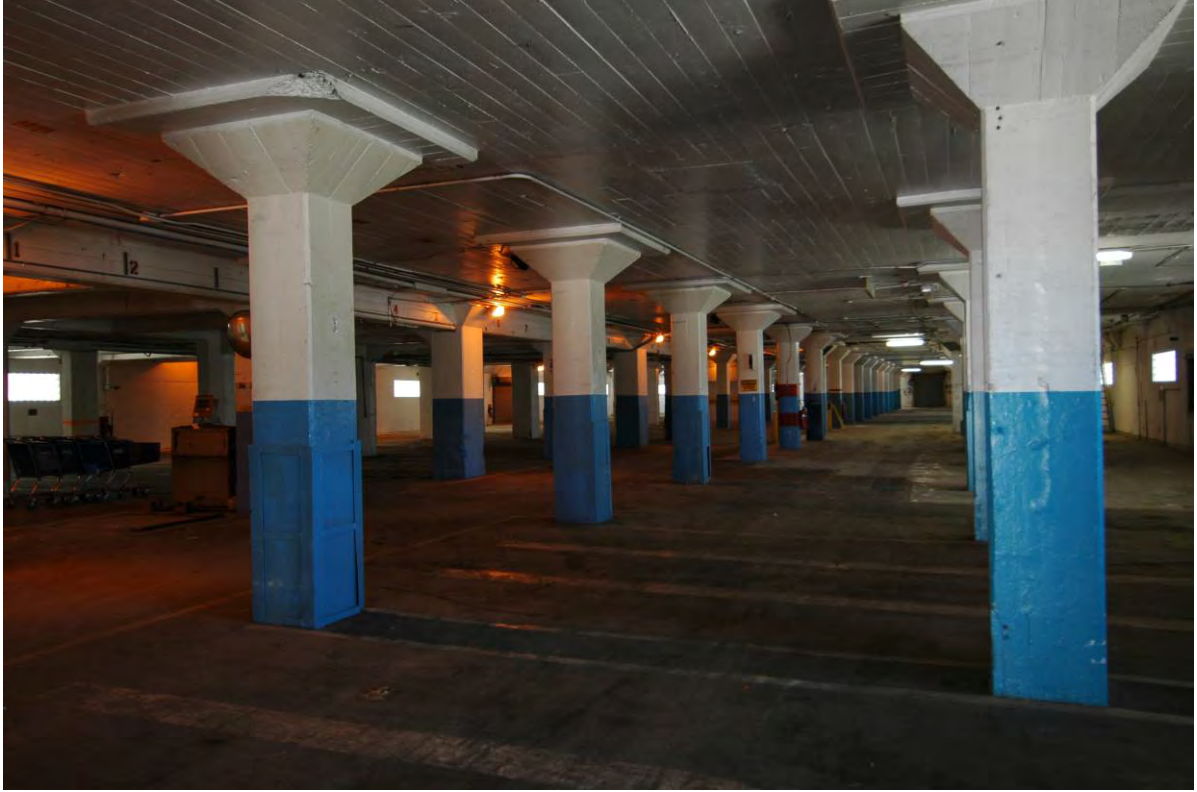
Mill, ground floor interior. Carey & Co. Inc., 2007.

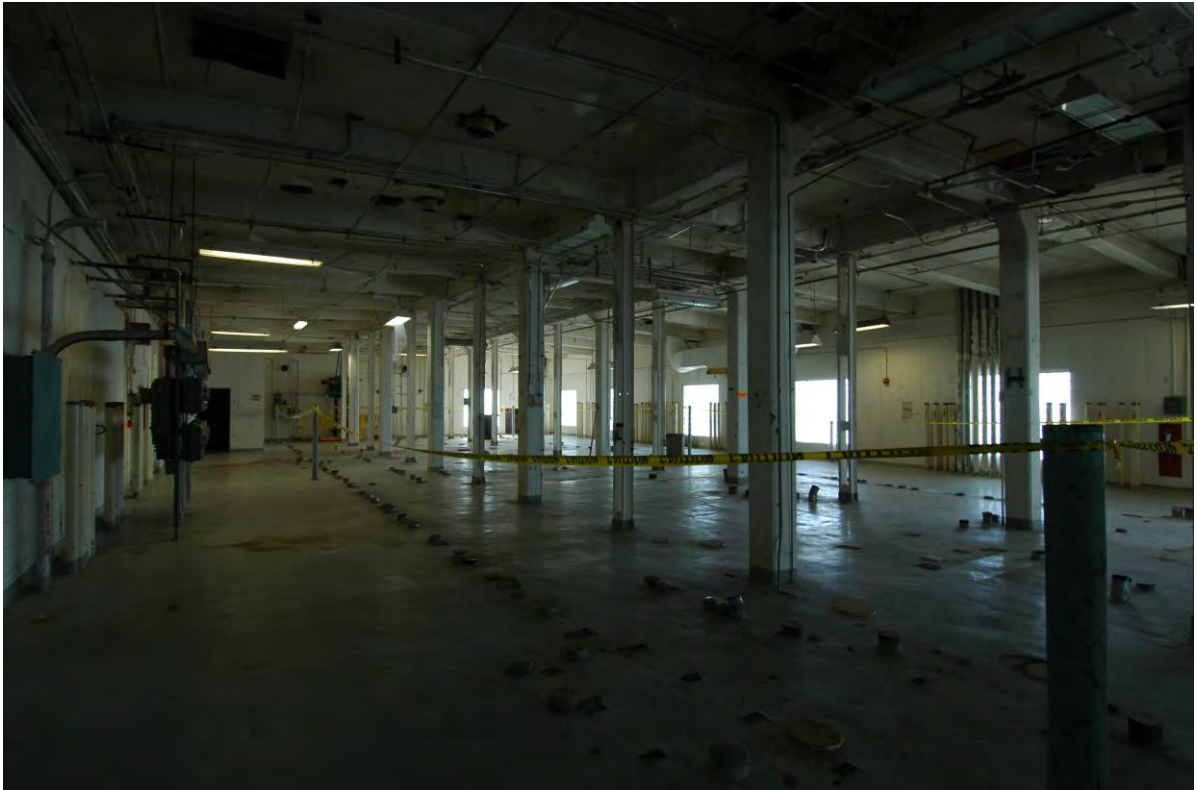
Mill, interior. One of the processing floors. Carey & Co. Inc., 2007.

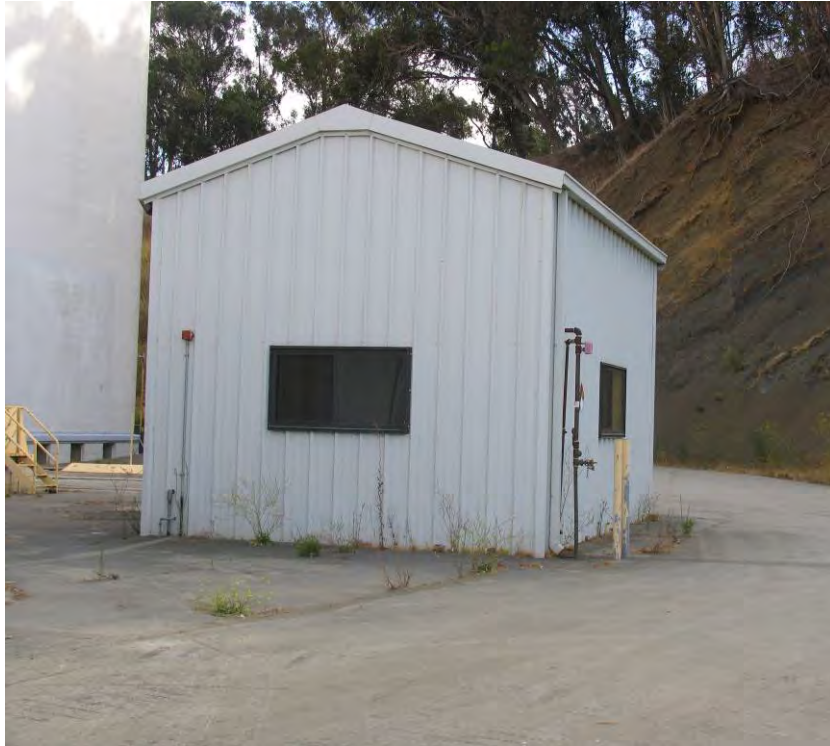
Forklift repair. Carey & Co., Inc., 2007.

This forklift repair is a small, gabled, one-story building clad entirely in corrugated metal and is square in plan. It has vinyl-sash slider windows on each side.

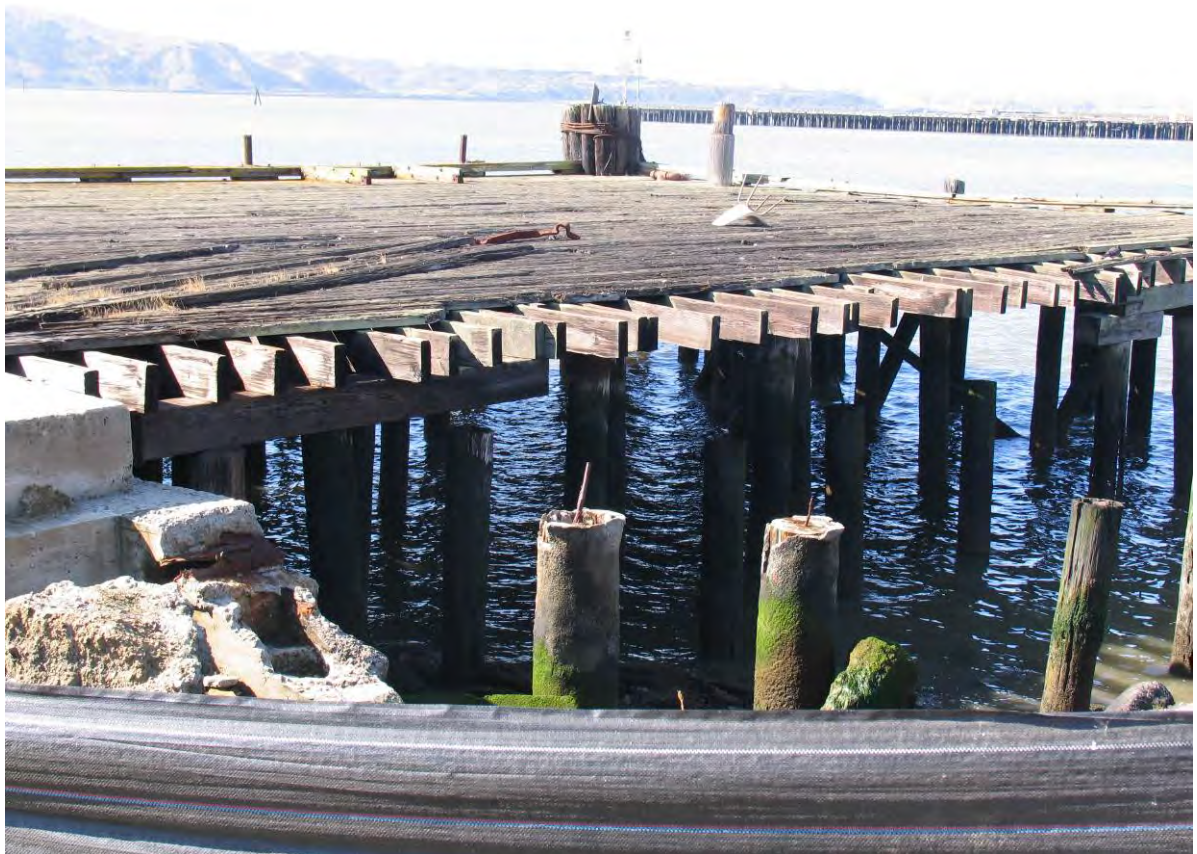
Dock with traces of railroad tracks. Carey & Co., Inc., 2007.

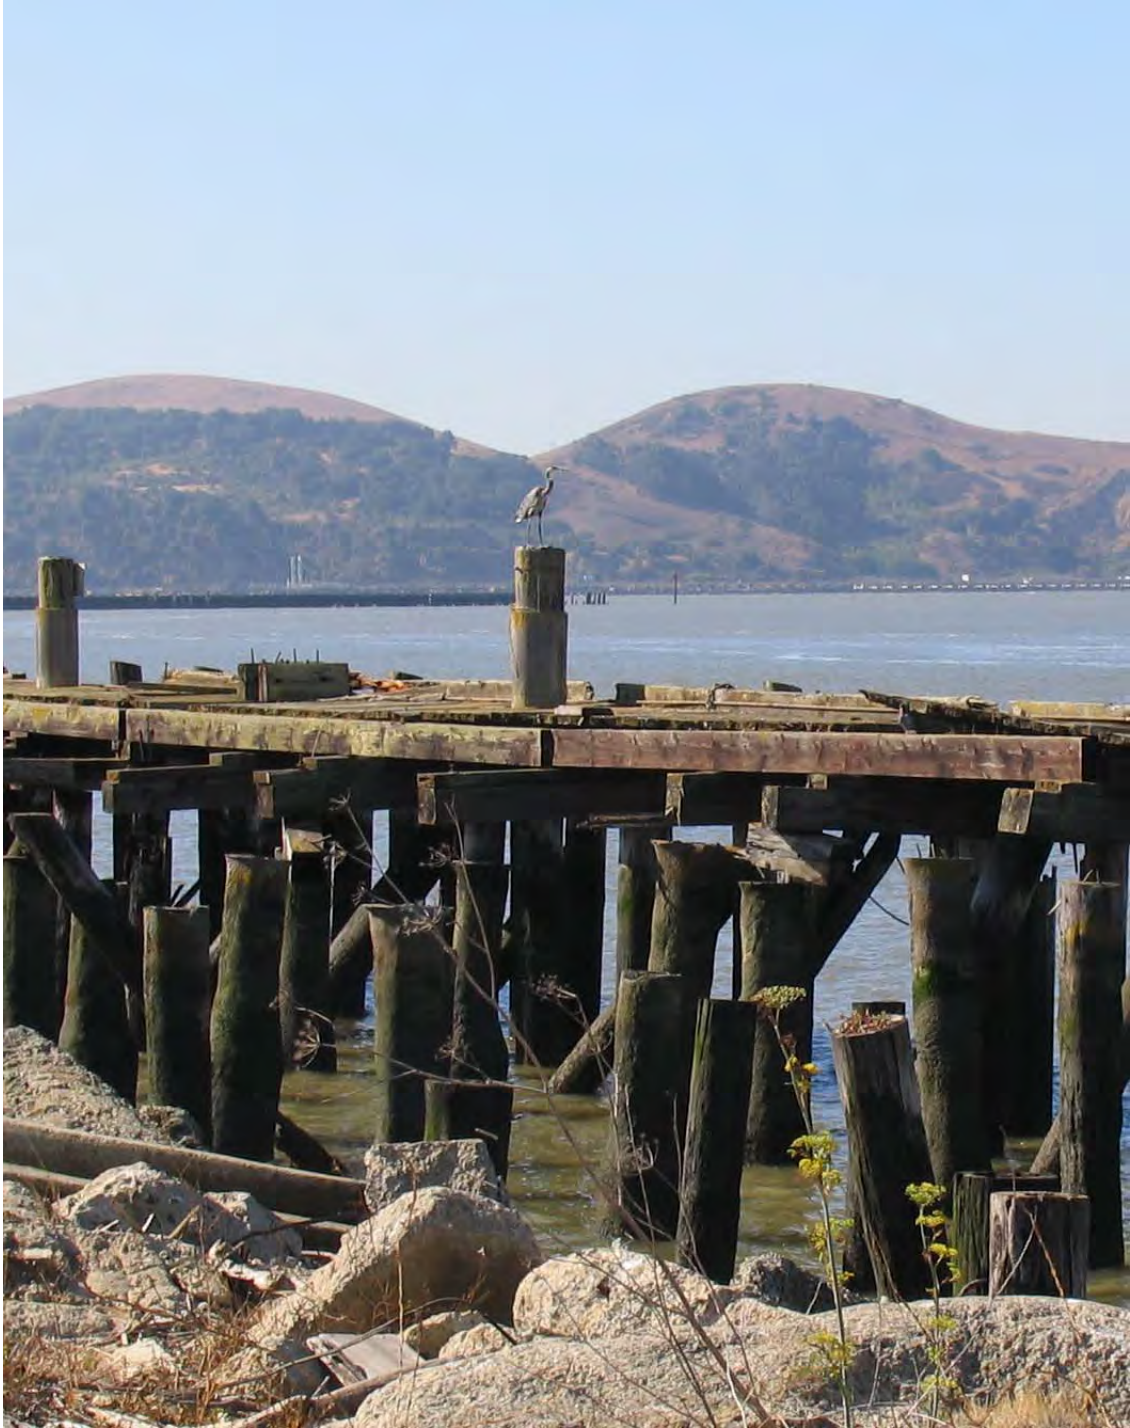
Representative example of piles and dock (with great heron). Carey & Co., Inc., 2007.

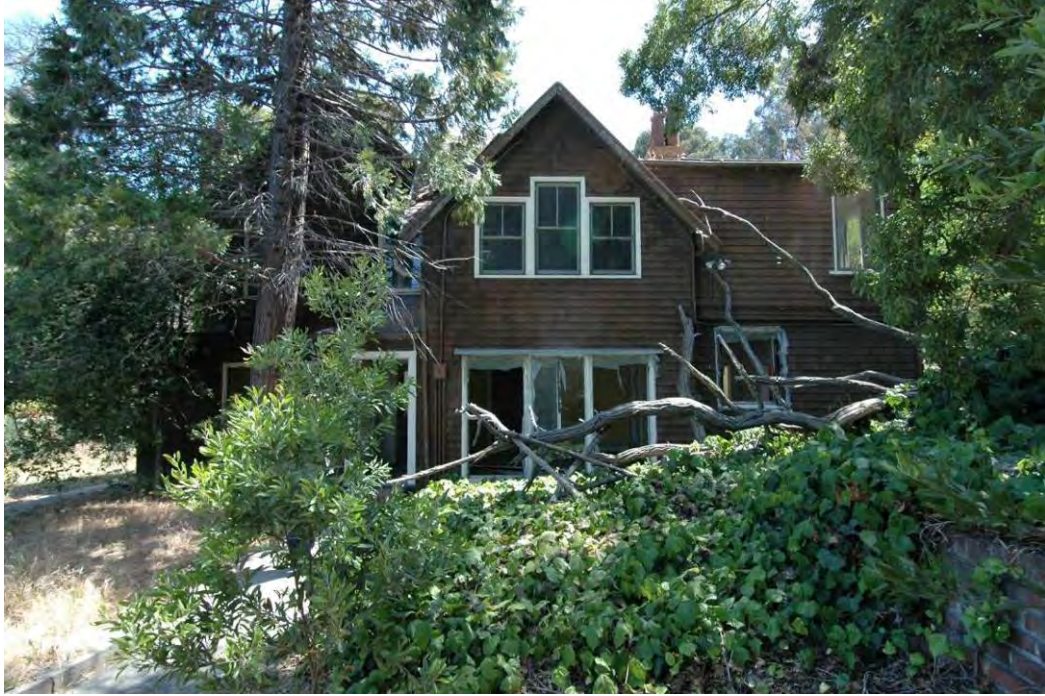
Manager's House, front (west) elevation. 1917 additions to left and right of central gable. Carey & Co., Inc. 2007.

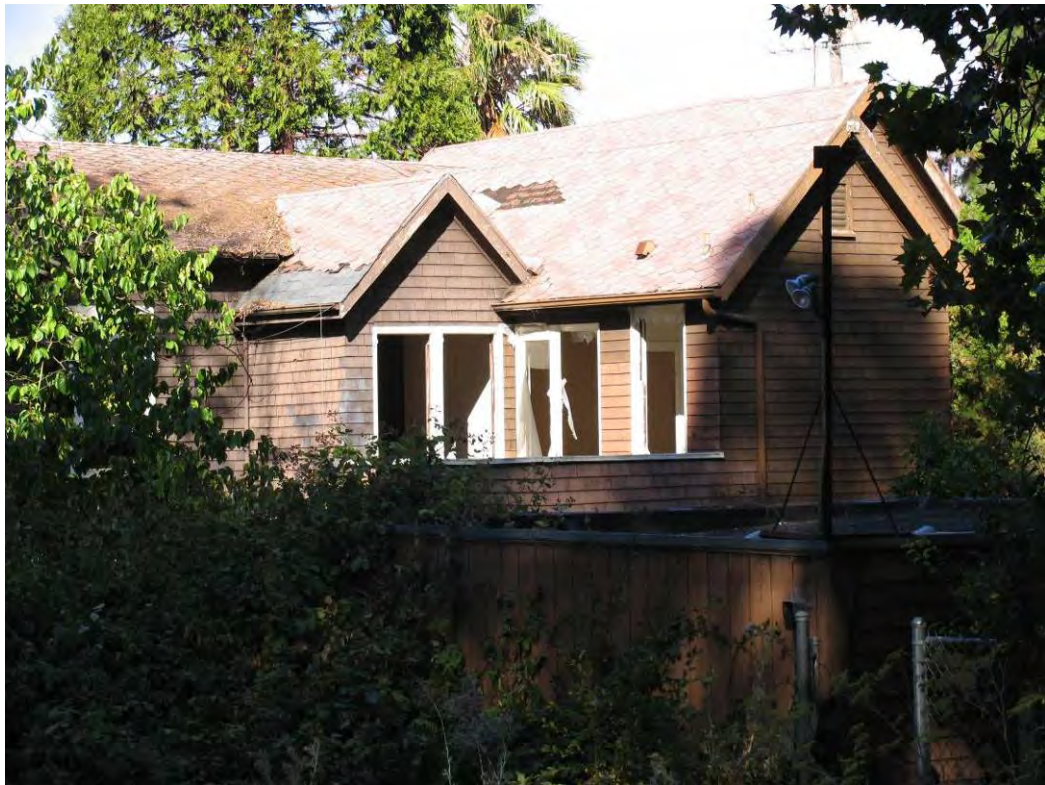
Manager's House, rear (southeast) elevation. Large gable is addition dating to 1919-1950. Second-story porch is post-1950 addition. Rear of garage in foreground. cCarey & Co., Inc., 2007.

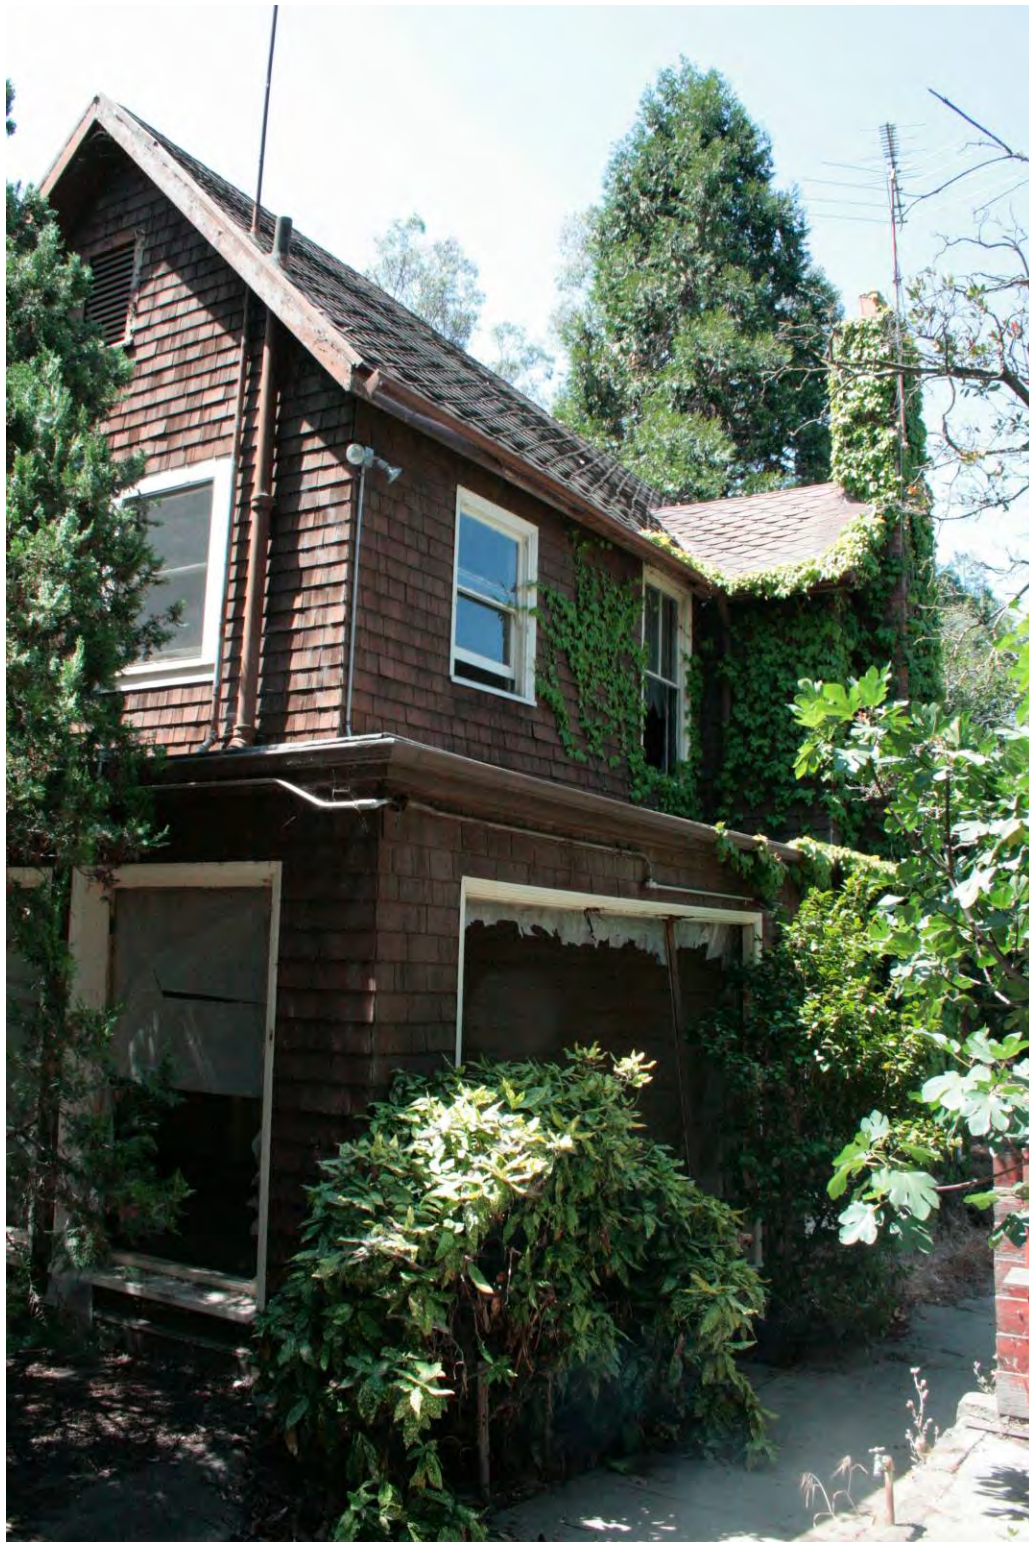
Manager's House, side (northeast) elevation showing 1919-1951 alteration to first story. Carey & Co., Inc., 2007.
