**APPENDIX I-5**  
*Final Backfill Report*

August 6, 2007

Final  
Backfill Report  
Large Excavation Site- Leasehold Property  
Former General Mills Facility  
Vallejo, California

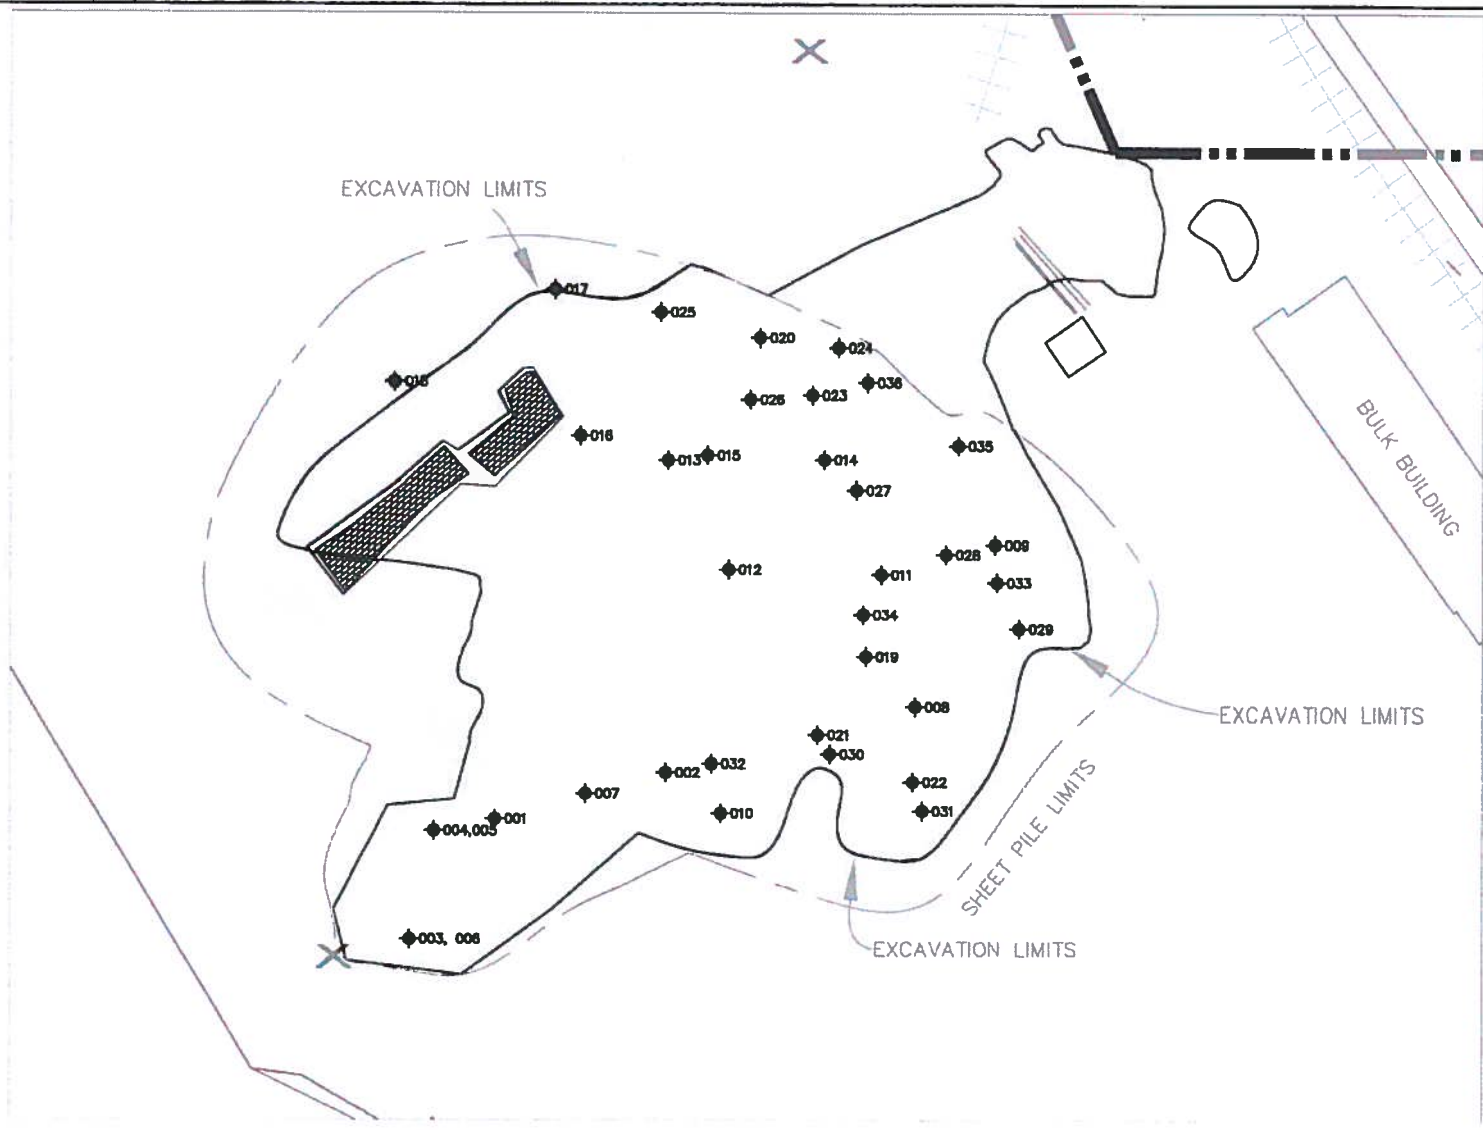
LOCATION:	Former General Mills Facility Vallejo, CA	ERRG PROJECT NO. 26-150
CLIENT:	Malcolm Pirnie, Inc.	FIG. NO. 3

Ninety five compaction tests (test numbers 001 through 095) were conducted on the quick lime mixed chemically-treated soil. The field compaction test results are summarized in Table 3 and the test locations are shown in Figures 3 to 5. In general the relative compaction was equal to or above the required 90 percent relative compaction except for the tests (test numbers 001 and 002) conducted in the first lift of compacted soil around the south-western tip. Due to the softness and wetness of the excavated subgrade, the compaction energy became less effective in that area. The relative compaction for those tests ranged from 84 to 89 percent. The subsequent lifts of soil, however, were placed and compacted on a more stable subgrade. Consequently, the relative compaction for the subsequent lifts was equal to or above 90%.

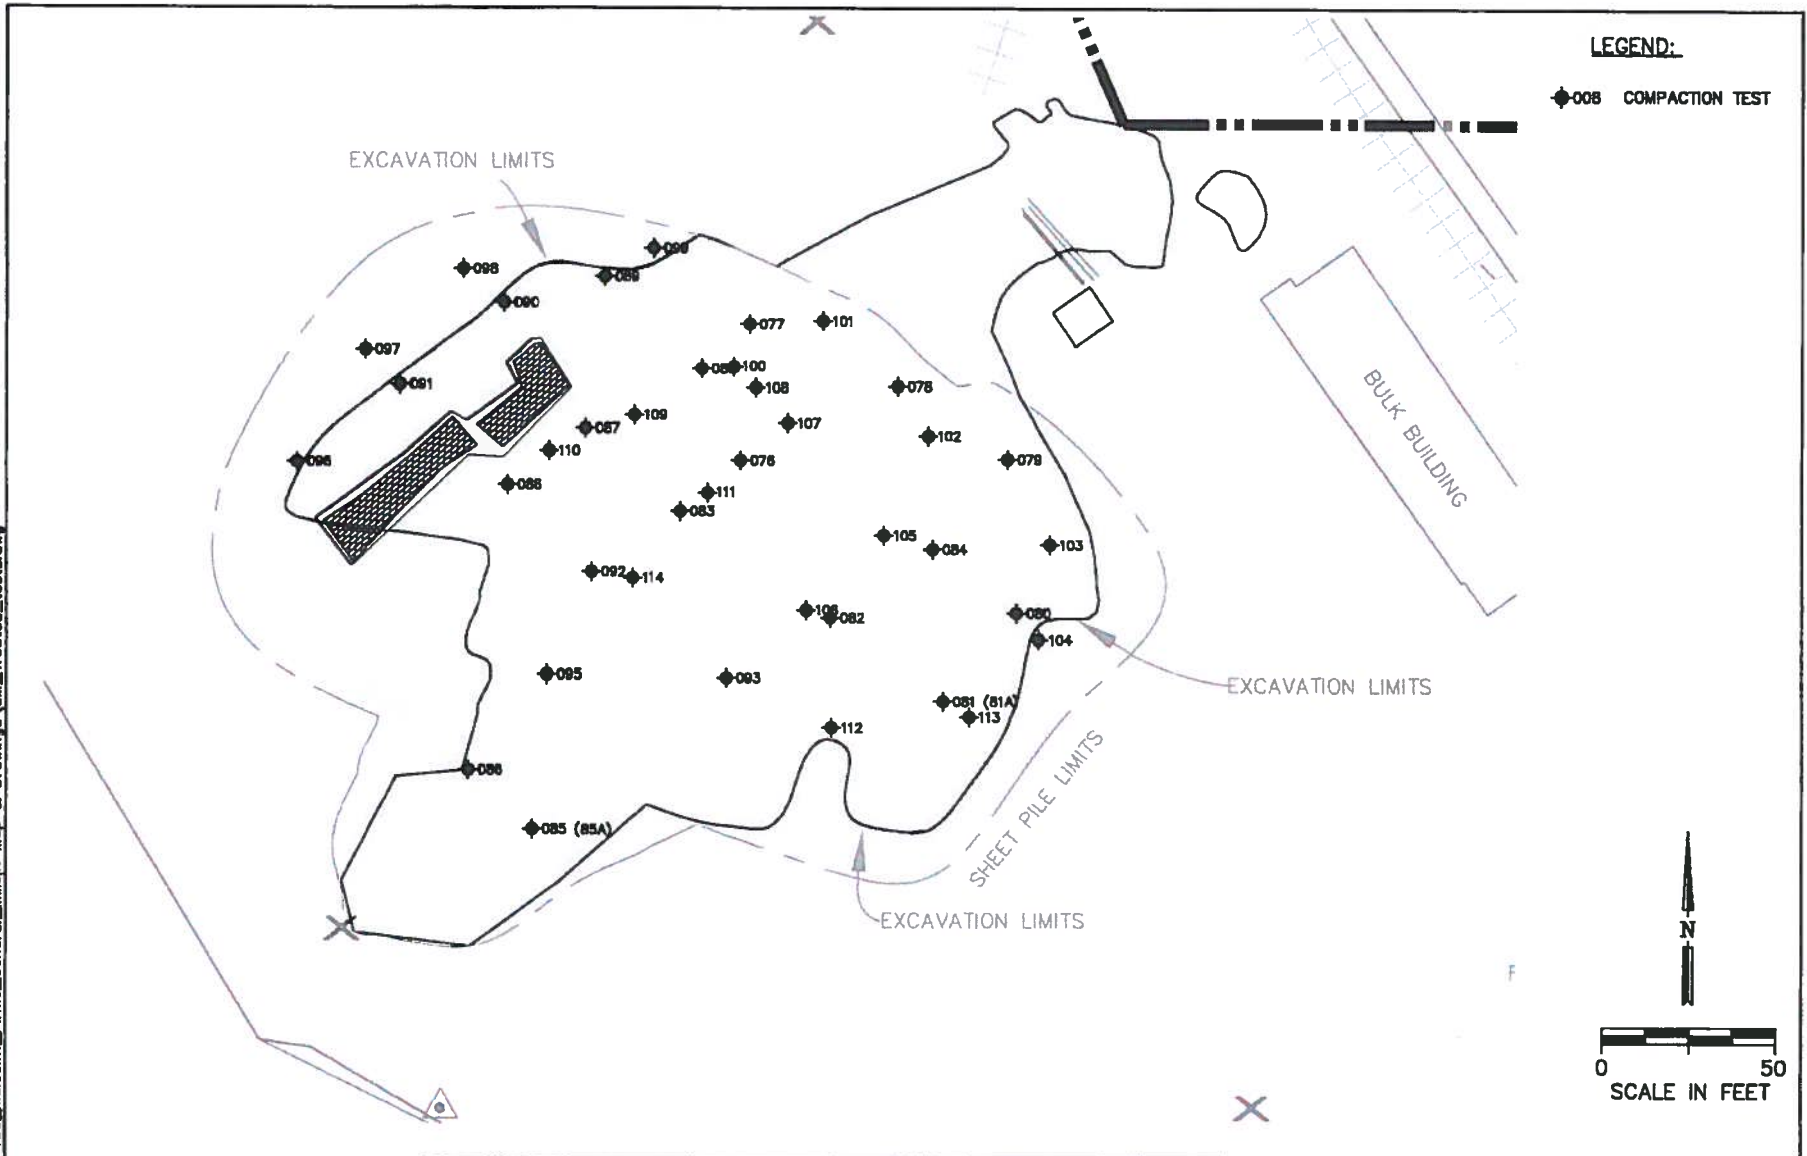
LOCATION:	Former General Mills Facility Vallejo, CA	ENRG PROJECT NO. 26-150
CLIENT:	Malcolm Pirnie, Inc.	FIG. NO. 5

085	5/11/2007	See Fig. 5	Fill/Treated	4.5	101.1	13.6	C302C0	88	Fail, See Retest 85A
086	5/11/2007	See Fig. 5	Fill/Treated	4	109.1	15.6	C302C0	95	Pass
087	5/11/2007	See Fig. 5	Fill/Treated	4	104.1	15.0	C302C0	91	Pass
088	5/11/2007	See Fig. 5	Fill/Treated	4	106.1	15.9	C302C0	92	Pass
089	5/11/2007	See Fig. 5	Fill/Treated	3.5	105.5	16.1	C302C0	92	Pass
090	5/11/2007	See Fig. 5	Fill/Treated	3.5	106.3	17.5	C302C0	93	Pass
091	5/11/2007	See Fig. 5	Fill/Treated	3.5	104.4	15.1	C302C0	91	Pass
092	5/11/2007	See Fig. 5	Fill/Treated	4	111.9	16.3	C1/4C0	93	Pass
093	5/11/2007	See Fig. 5	Fill/Treated	4	115.6	16.2	C1/4C0	96	Pass
85A	5/11/2007	See Fig. 5	Fill/Treated	5.5	105.2	16.1	C302C0	92	Pass
094	5/11/2007	See Fig. 5	Fill/Treated	4	117.2	17.8	C1/4C0	97	Pass
095	5/11/2007	See Fig. 5	Fill/Treated	4.5	105.1	16.4	C302C0	91	Pass

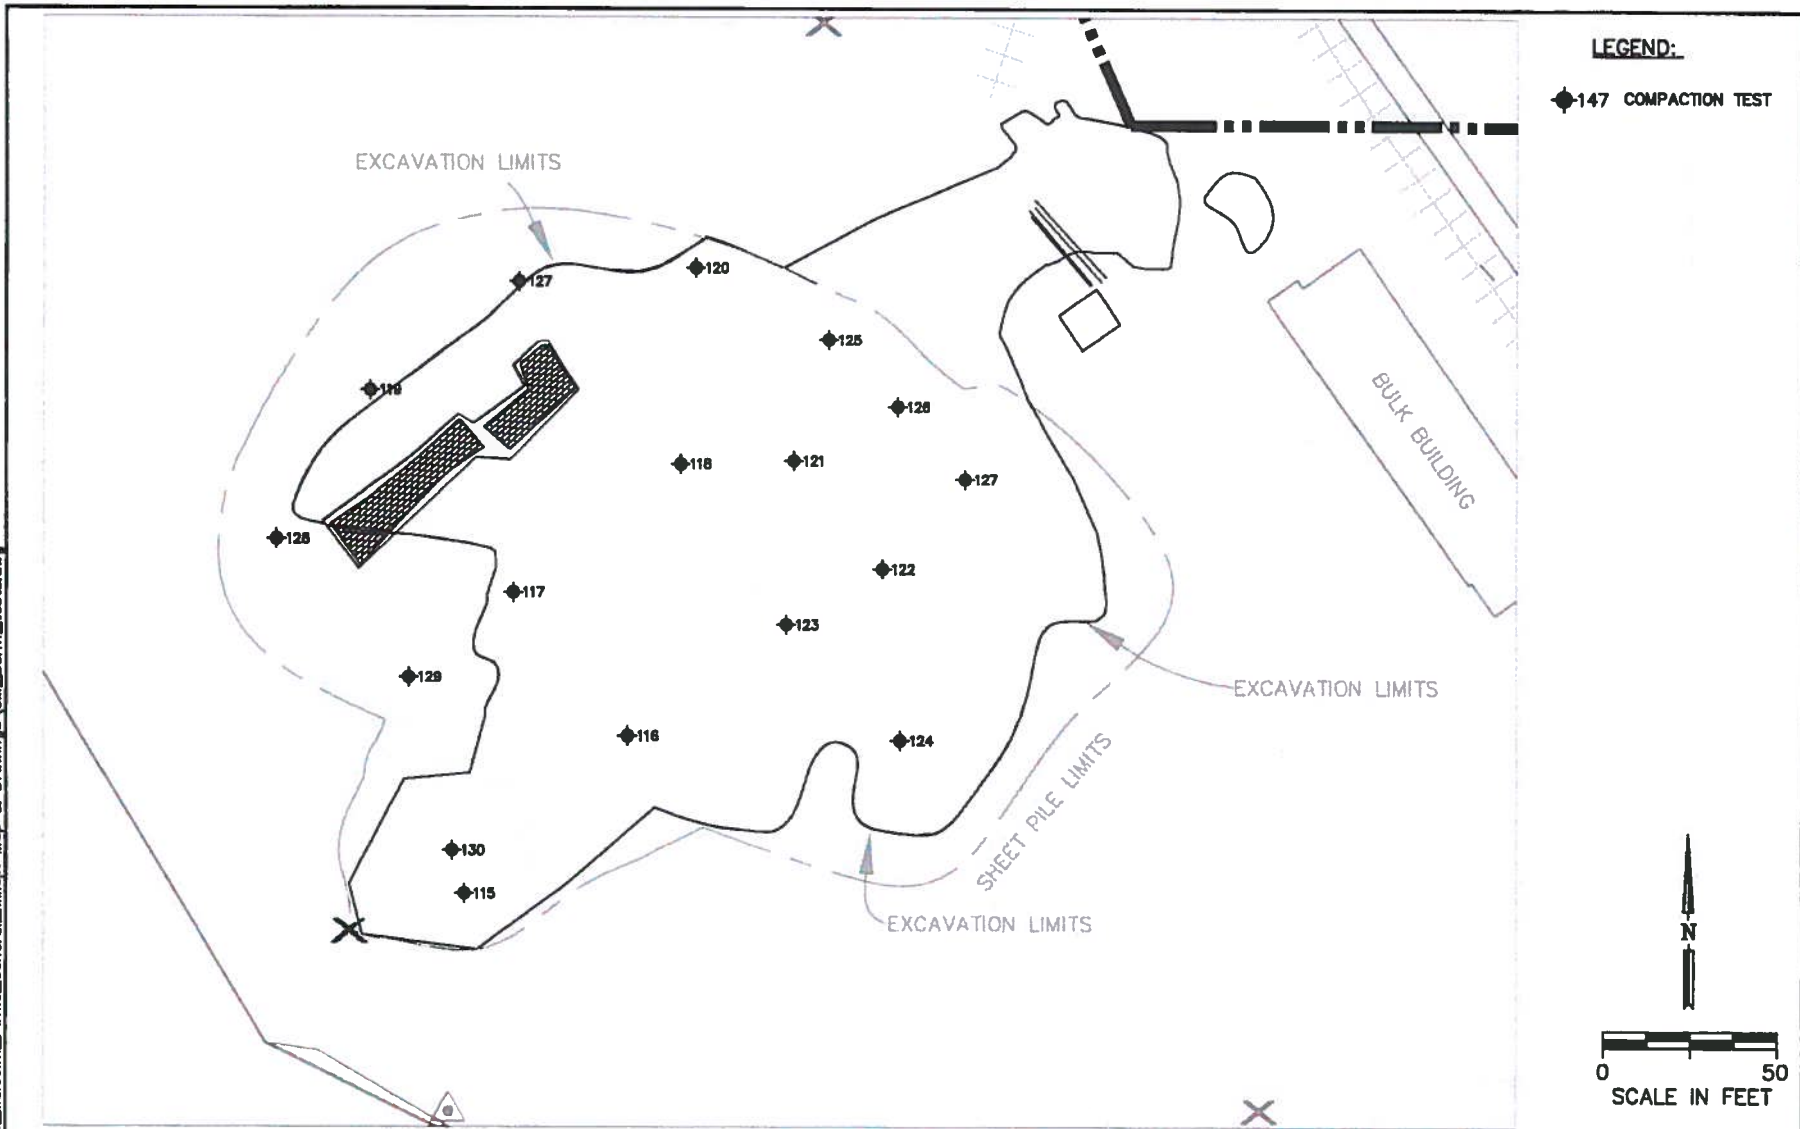
LOCATION:	Former General Mills Facility Vallejo, CA	ENRG PROJECT NO. 26-150
CLIENT:	Malcolm Pirnie, Inc.	FIG NO. 6

The backfilling operation using overburden soil began on May 14, 2007. Thirty five compaction tests (test numbers 096 through 130) were conducted on the compacted overburden soil from 2 to 3 feet bgs. The field compaction test results are summarized in Table 3 and the test locations are shown in Figures 5 to 6. The relative compaction was equal to or above 90 percent (as required). Eighteen compaction tests (test numbers 131 through 148) were conducted on the compacted overburden soil from 1 to 2 feet bgs. The field compaction test results are summarized in Table 3 and the test locations are shown in Figure 7.
