APPENDIX I-5
Final Backfill Report

Final
Backfill Report
Large Excavation Site- Leasehold Property
Former General Mills Facility
Vallejo, California

Engineering/Remediation Resources Group, Inc. (ERRG) is pleased to submit this letter report summarizing the earthfill placement and construction quality assurance activities for the above referenced project. The large excavation site is located at the western edge of the former General Mills Facility, 800 Derr Street, Vallejo, California as shown in Figure 1. The approximate excavation boundary is shown in Figure 2.

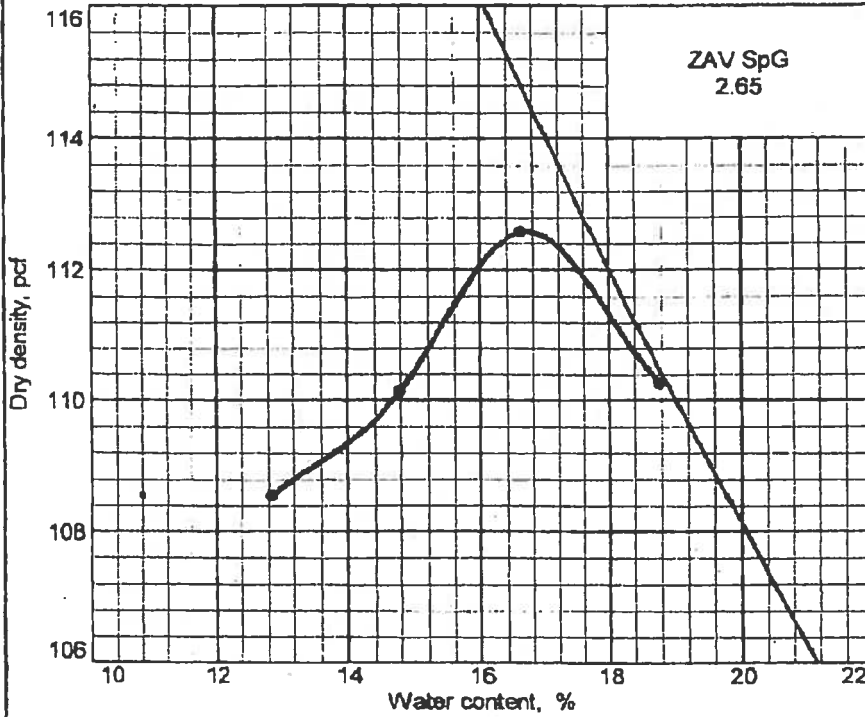
Curve No.
2

Test Specification:
ASTM D 1557-91 Procedure A Modified

1	2	3	4	5	6
WM + WS	1911.0	1985.0	1980.0	1852.0		
WM	0.0	0.0	0.0	0.0		
WW + T #1	1911.00	1985.00	1980.00	1852.00		
WD + T #1	1665.00	1702.00	1667.00	1641.00		
TARE #1	0.00	0.00	0.00	0.00		
WW + T #2						
WD + T #2						
TARE #2						
MOISTURE	14.8	16.6	18.8	12.9		
DRY DENSITY	110.1	112.6	110.3	108.5

TEST RESULTS	Material Description
Maximum dry density = 112.6 pcf Optimum moisture = 16.7 %	OLIVE CRUSHED CLAYSTONE
Project No. 98566 Client: ERRG #26-150 Project: MP VALLEJO • Location: HEAD OF EXCAVATION	Remarks: 1-5-2007 CLIENT/JPM
COMPACTON TEST REPORT CONSTRUCTION MATERIALS TESTING INC.	Plate

Sample	Material/Fill Type	Test	Test Designation	Results
1	Overburden soil (Sandy lean clay with gravel)	Modified Proctor Density	ASTM D1557	Maximum dry density = 112.6 pcf; Optimum moisture content = 16.7 %
2	Overburden soil (Claystone)	Modified Proctor Density	ASTM D1557	Maximum dry density = 124.3 pcf; Optimum moisture content = 11.7 %
BC3C0	Overburden soil (Clayey gravel with sand)	Modified Proctor Density	ASTM D1557	Maximum dry density = 118.9 pcf; Optimum moisture content = 14.2 %
BC4C0	Overburden soil (Silty gravel with sand)	Modified Proctor Density	ASTM D1557	Maximum dry density = 127.5 pcf; Optimum moisture content = 10.0 %
BC6C0	Overburden soil (Clayey gravel with sand)	Modified Proctor Density	ASTM D1557	Maximum dry density = 124.8 pcf; Optimum moisture content = 9.2 %
01-03	Treated soil laboratory admixed with 4% quick lime (Silty gravel with sand)	Modified Proctor Density	ASTM D1557	Maximum dry density = 113.2 pcf; Optimum moisture content = 15.3 %
