**GEOTECHNICAL AND  
ENVIRONMENTAL CONSULTATION  
GGBS MANUFACTURING FACILITY  
Vallejo, California**

**Ecocem Materials  
Dublin, Ireland**

**20 February 2013  
Project 731608801**

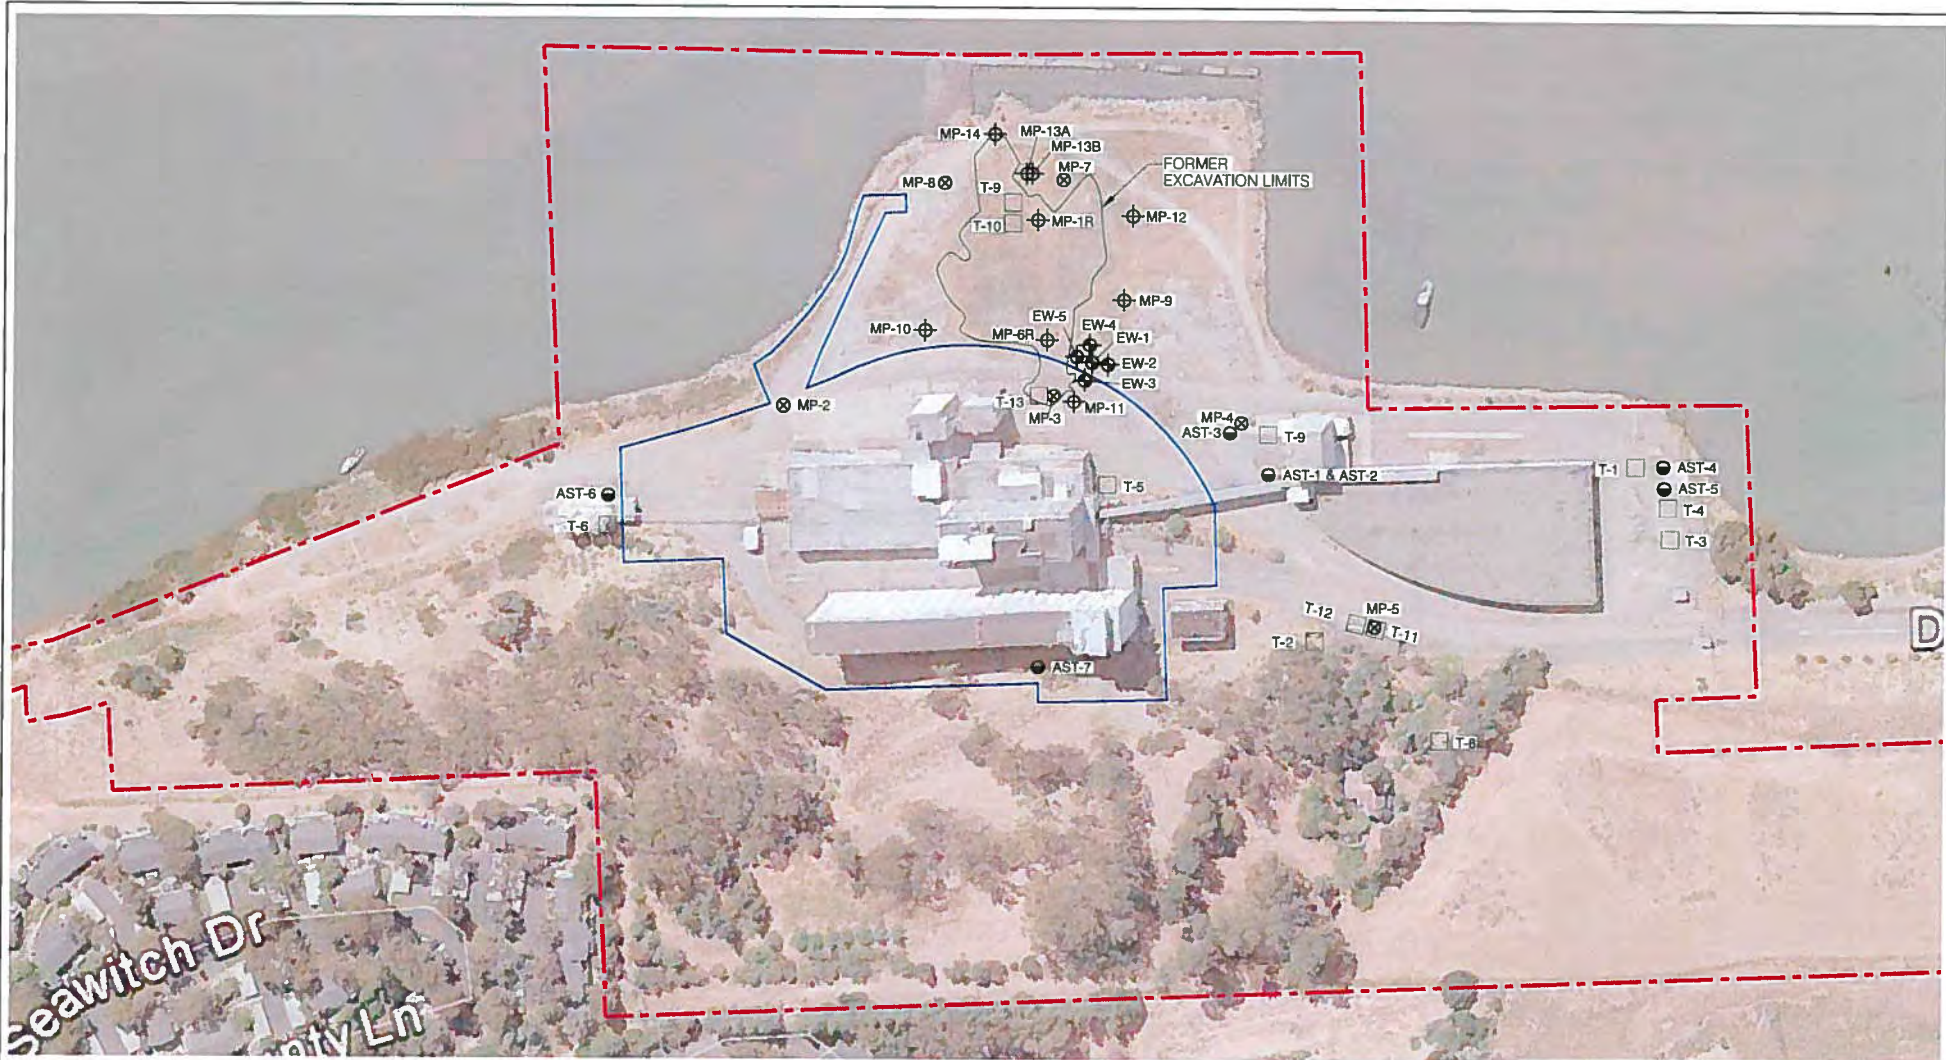
- T-6 □ Approximate location of former underground storage tank (UST)
- AST-3 ● Approximate location of former above ground storage tank (AST)
- MP-2 ⊕ Approximate location of monitoring well by Malcolm Pirnie, July 2007
- EW-1 ⊕ Approximate location of extraction well by Malcolm Pirnie, October 2011

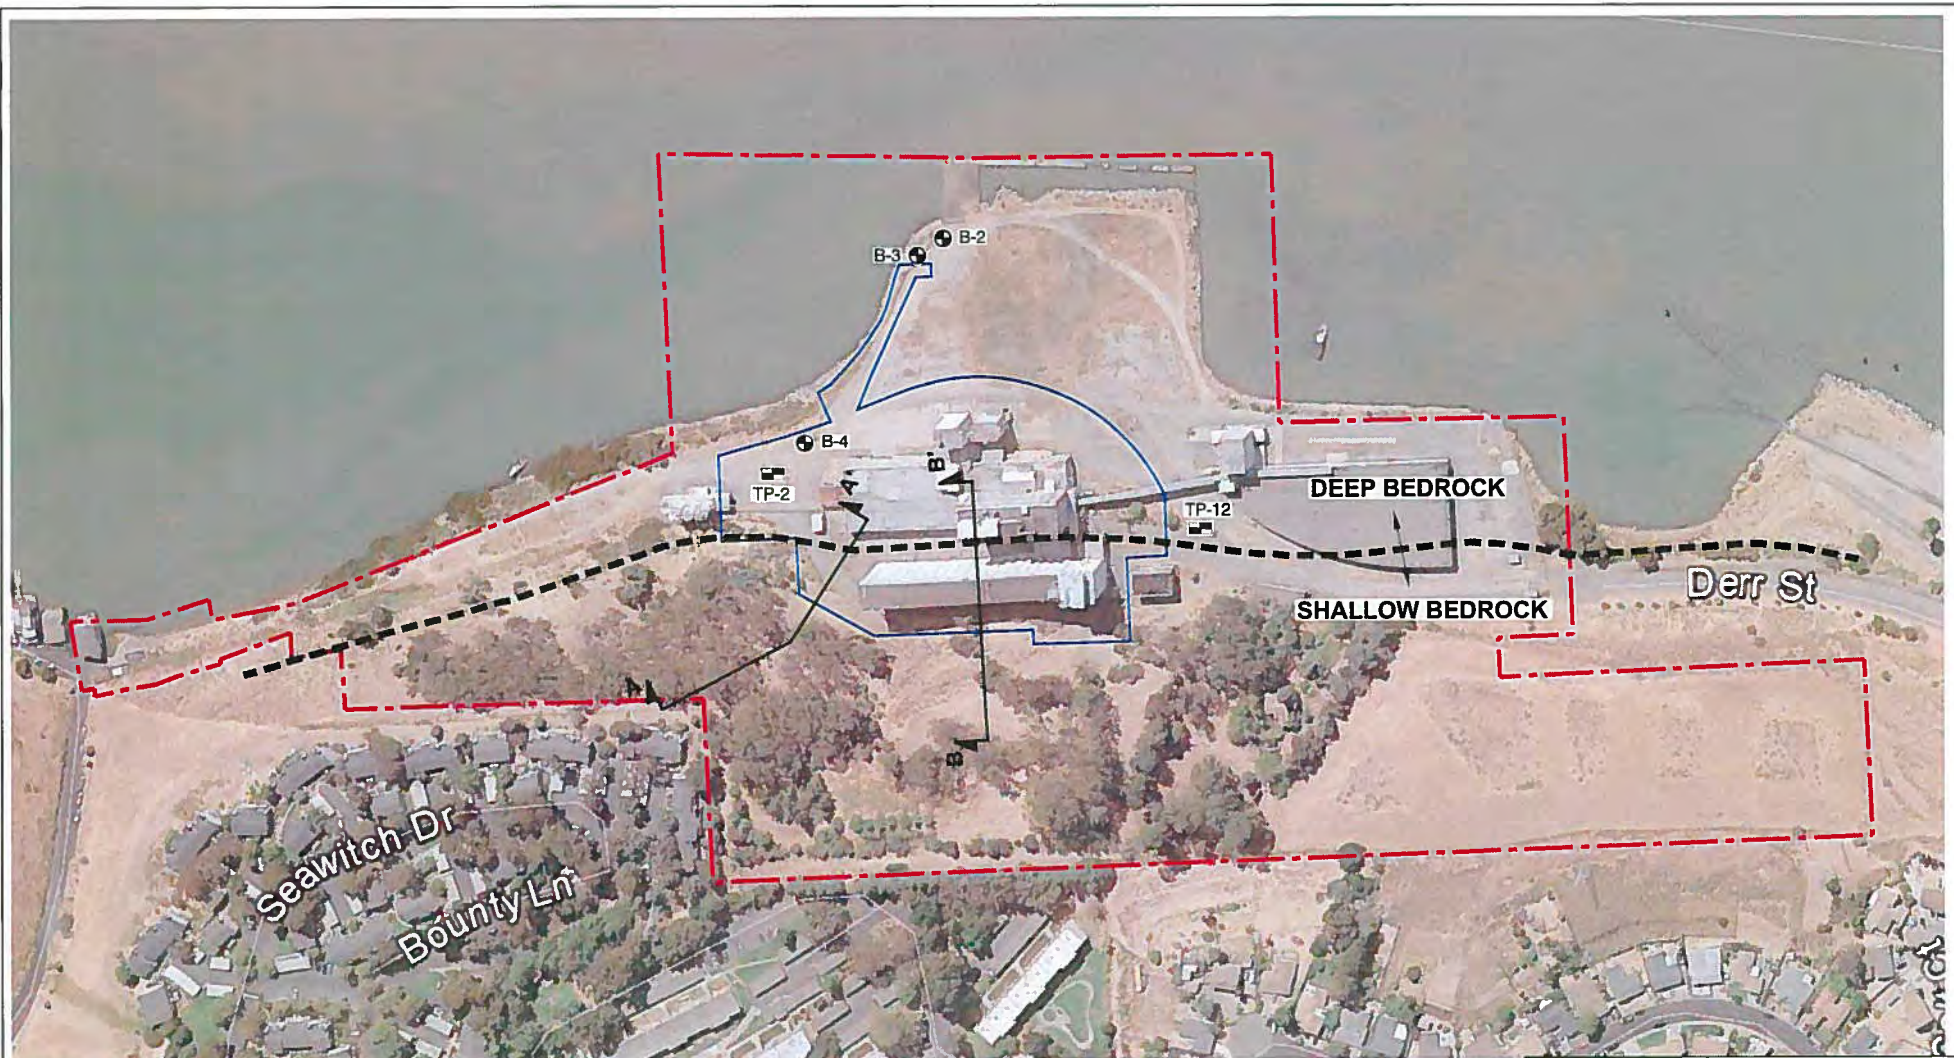
<b>GGBS MANUFACTURING FACILITY</b> Vallejo, California		
<b>SITE PLAN SHOWING</b> <b>GEOTECHNICAL INFORMATION</b>		
Date 02/15/13	Project No. 731608801	Figure 3
<b>Treadwell &amp; Rollo</b> <small>A LANGAN COMPANY</small>

- EXPLANATION**
- Approximate location of Grain Mill boundary
  - Approximate Site boundary
  - Approximate demarcation between shallow and deep bedrock
  - Idealized subsurface profile location

- B-3 Approximate location of boring by Engeo, April 2006
- TP-2 Approximate location of test pit by Engeo, April 2008

The reports by Engeo included several borings and test pits that were excavated on and around the portion of the property under consideration. They are limited in number and only a few were on the site of interest; these are shown on Figure 3. Additionally, the 2008 Engeo report included a geologic map of the site. The reports by Engineering/Remediation Resources Group (ERRG) relate to removal of contaminated soil and replacement thereof with compacted fill. The remediation does not extend onto the property currently being considered for purchase, and the reports are therefore only of general interest.

The western portion of the site appears to be blanketed by clayey fill. The fill is either underlain by directly by bedrock or soft clay locally referred to as Bay Mud, which overlies bedrock. The contact between bedrock (or shallow bedrock) and fill (deep bedrock) as mapped by Engeo is approximately as shown on Figure 3.

We performed engineering analyses to evaluate the stability of the descending slopes on the northeast and east sides of the site, along the alignments of profiles A-A' and B-B' as shown on Figure 3. These profiles were generated based on subsurface and topographic information provided in the Engeo report dated 27 June 2008. They were selected to represent the most critical slopes from a topographic standpoint that may impact the site. We concluded that the critical slope condition appears to be in the southeast corner of the site, near Mr. Durnal's profile D-D'. We performed an analysis on a profile of the slope at this critical location (our A-A'), and a second analysis on a profile just southwest of Mr. Durnal's B-B' profile (our B-B').
